Docket No. 217 – Development and Management Plan Inspection

Northeast Utilities Service Company Certificate of Environmental Compatibility and Public Need for the construction of a 345-kV electric transmission line and reconstruction of an existing 115-kV electric transmission line between Connecticut Light and Power Company's Plumtree Substation in Bethel, through the towns of Redding, Weston, and Wilton, and to the Norwalk Substation in Norwalk, Connecticut.

Date: June 7, 2006

Location: Overhead Line (Composite 345kV and 115kV Gallows Hill to Archers Lane,
345kV H-Frame Hoyts Hill to Gallows Hill, and Norwalk Section)

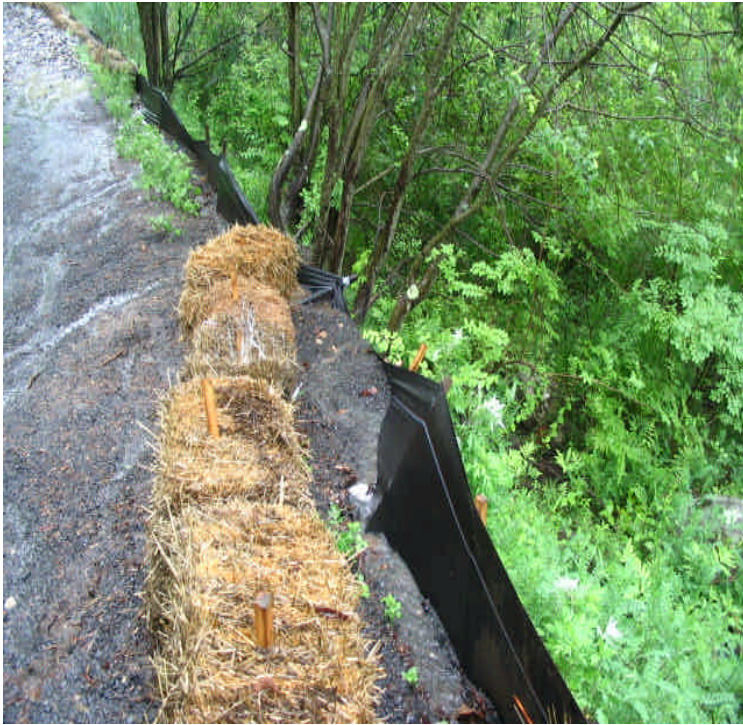
- One spot along the access road past Archers Lane has stone dust from the road overtopping the silt fence adjacent to the wetland. A second spot is also piling up. 6/7/06.	- Repairs should be made either by transition station or overhead crews. Stone/sediment needs to be removed. 6/1-6/7/06.	-Needs attention- also see transition station report.
345kV H-Frame	- Other work areas are	-Continue to monitor the	- N/A at this time

(Composite Section): Photo on the left shows an area of silt fence that was overtopped with stone dust along the access road in the ROW past Archers Lane. Photo on the right shows a spot in the same area where sediment is piling up. 6/7/06

- Silt fence is being overtopped and/or sediment is piling from run-off on the access road past Archers Lane. 6/1-6/7/06	-The overtopped area should be repaired with stone pulled back and removed from the wetland. Continue to monitor the second spot. 6/1-6/7/06	- Needs attention from either transition station or overhead crews

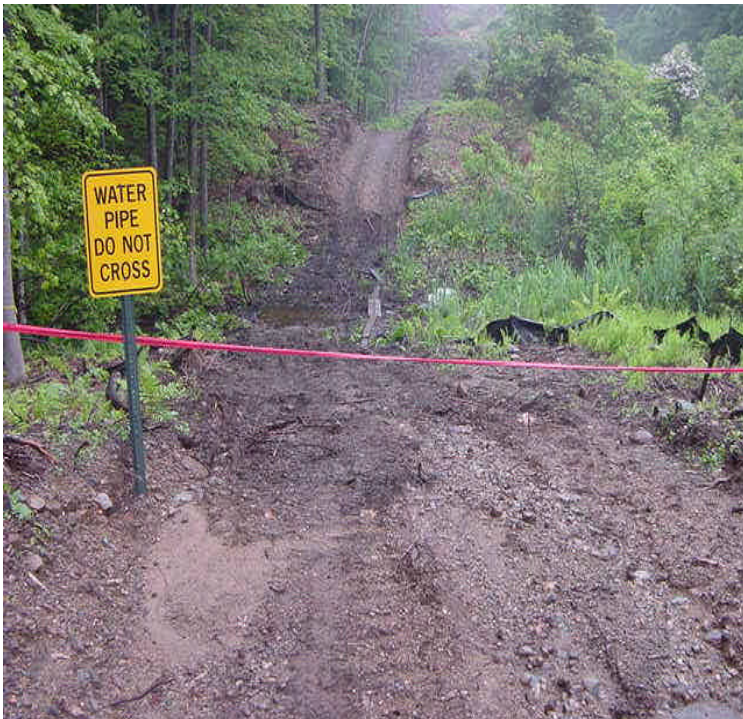
- A vehicle accidentally drove through the wetland between poles #10-11 after mats were removed. Some ruts were created but the water main was not damaged. 5/25-6/7/06	- See erosion control section for more details but ruts should be smoothed out and additional controls installed. 5/25-6/7/06 A sign was installed to prevent further trips	- Needs attention (some reports from adjacent landowners have noted non project related vehicles in this area)

- A vehicle accidentally crossed the stream & wetland between poles #10-11. Some ruts were created in the wetland. 5/25-6/7/06	- The ruts in the stream or wetland should be smoothed out. (No damage to the water main had occurred.) 5/25-6/7/06	- Needs attention
	Disturbed soil remained on the access road adjacent to the wetland	Additional controls should be placed across the ROW to prevent	- Needs attention. This will also help to keep out any non project

(345kV H-Frame): Photo on the left shows a view of the wetland between structures #10 and 11. Silt fence still needs to be installed across the ROW on both ends and the surface restored where necessary. Photo on the right shows a washout off the Bethel Reservoir access road. 6/7/06.

- A vehicle had accidentally tracked through the wetland between #10-11 several weeks ago. 6/1-6/7/06	- Ruts should be smoothed out and additional controls are needed. 5/25-6/7/06	-Needs attention (Silt fence will also keep out non project related vehicles)
Norwalk Section	-The pond, stream, and pooled area in the new ROW section off Kent Rd were not impacted with turbidity, even during heavy rains. 6/7/06.	-Carefully remove some of the branches and debris noted in the stream and extend silt fence where recommended. 6/7/06.	-N/A but see erosion control section
All Sections	- Remove sediment carefully from any wetland areas and pull back silt fence and repair. 6/7/06	- Retain shrubs and low growth as much as possible, especially at stream buffers. 3/2-6/7/06.	- Needs attention.

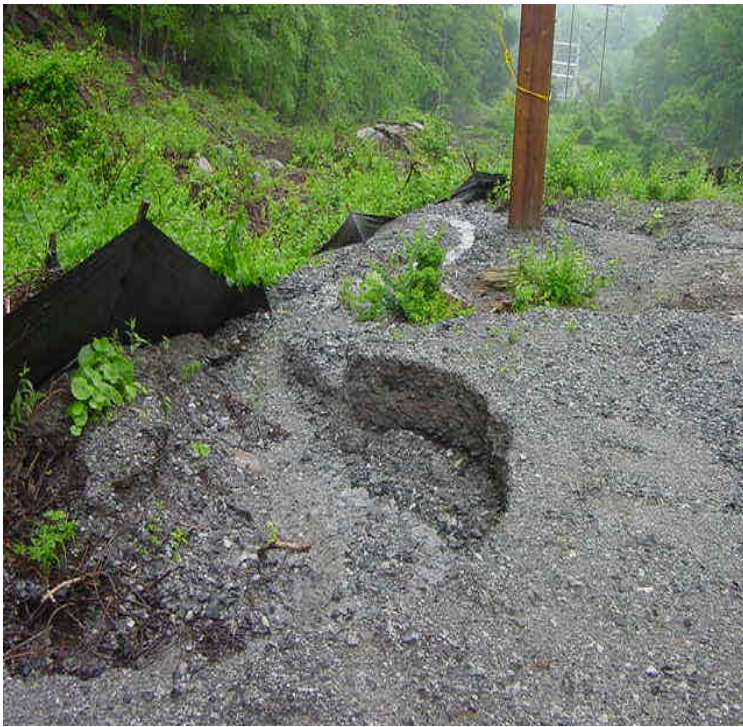
- Large erosive washouts were also noted within the stone dust at structure #2. 6/7/06	- This will need to be repaired and stone pulled back from beyond the silt fence.	- Needs attention when feasible.

Photo on the left shows washout and erosion near structure #2. Photo on the right shows erosion primarily within the wood chips between structures #5-6. The area will be back bladed to restore the chips. 6/7/06.

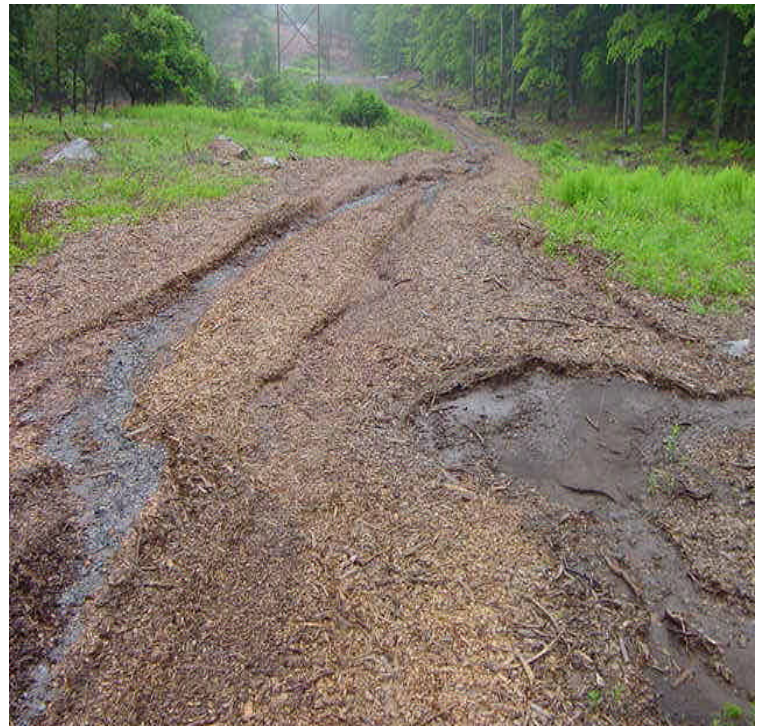
Areas of Inspection	Observation	Recommended Action	Corrective Action
Norwalk Section	accessed from Hoyts Hill, Chestnut Ridge Rd, the Bethel Res. water plant road, Lime Kiln Rd, Whortleberry Rd, John Todd Way and Costa Lane. 3/29-6/7/06. - Washouts were noted within the wood chips in the access road between poles #5-6. 6/7/06	conditions of all access roads. If muddy conditions re-occur, place more wood chips or consider installing silt fence as needed. 6/7/06. - The wood chips will be back bladed to restore the washouts 6/7/06	- Needs attention when feasible.

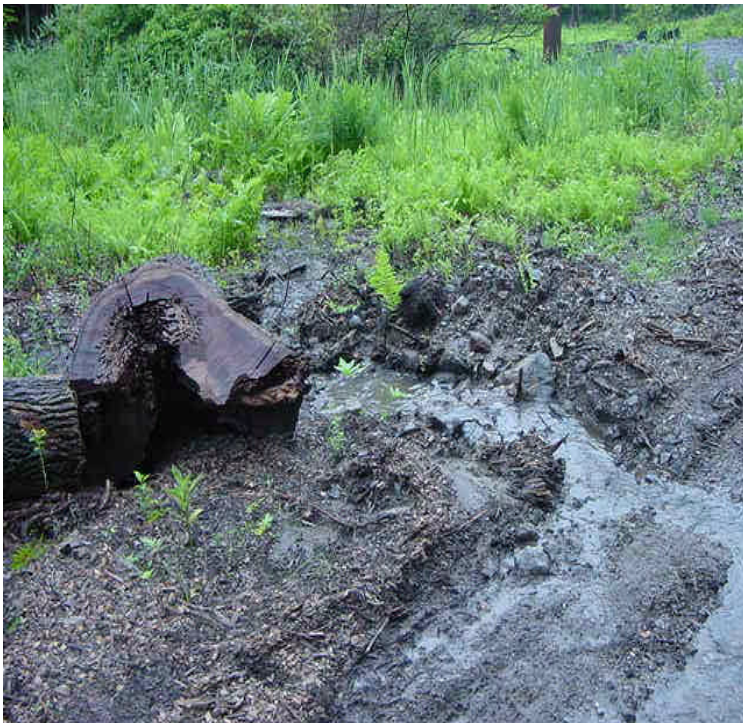
- A low spot at the access road is leading to turbid run-off to the wetland near structure #6. 6/7/06	- Install haybales or silt fence to slow and filter this run-off. 6/7/06	-Needs attention

- Turbid run-off is pooling along the access road and running to the wetland adjacent to structure #6. 6/7/06	- Place haybales or silt fence to slow and filter run-off. 6/7/06	- Needs attention
Bethel Reservoir Section to Chestnut Ridge Rd.	-Sediment washed under the silt fence near structure #19. It reached the adjacent wetlands here. 6/7/06.	- The silt fence needs repair and the sediment should be pulled back carefully. 6/7/06.	-Needs attention

Photo on the left shows where run-off from the access road is flowing to the wetlands near structure #6. Haybales should be placed at this area. Photo on the right shows where sediment had overtopped the silt fence near structure #24. Repairs are needed here and at #25. 6/7/06.

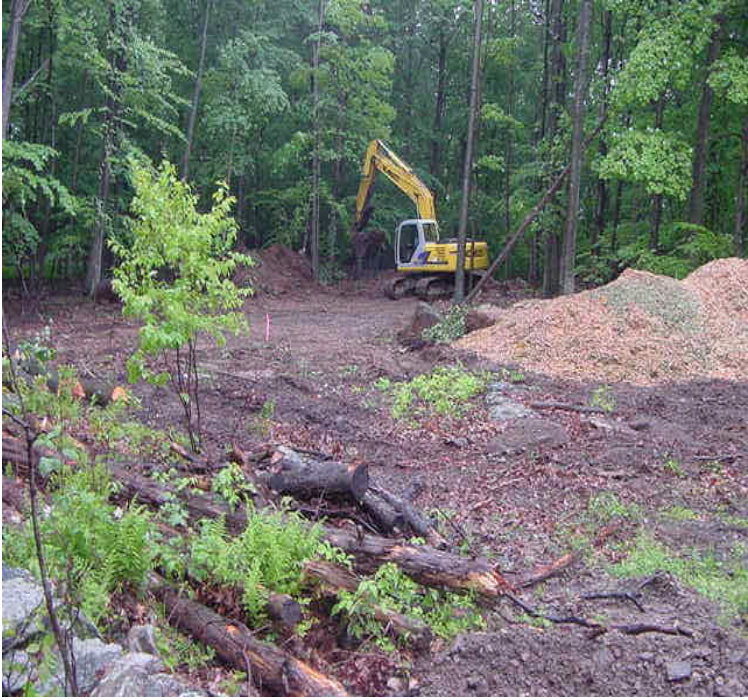
Photo on the left shows a separate contractor (unrelated to the project) installing a driveway near John Todd Way. This contractor had several erosion control and storage issues that are not in the jurisdiction of the project. (Norwalk Section Kent Rd): Photo on the right shows the silt fence installed along the pond's edge in the new ROW section. 6/7/06.

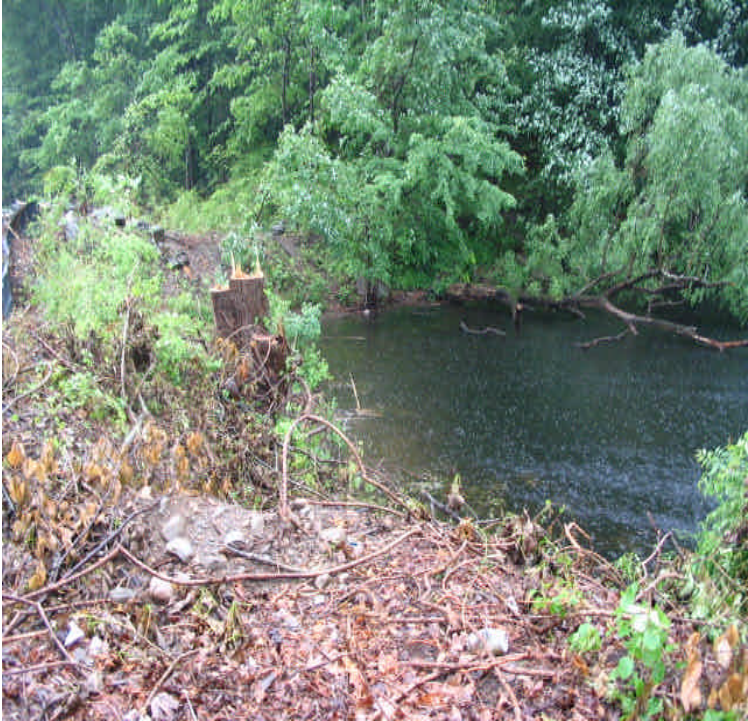
Photo on the left shows the bank of the pond beyond the silt fence. Water showed no signs of turbidity during the heavy rains and some stumps and shrubs were in place. Photo on the right shows another view of the pond with some shrubs remaining. 6/7/06

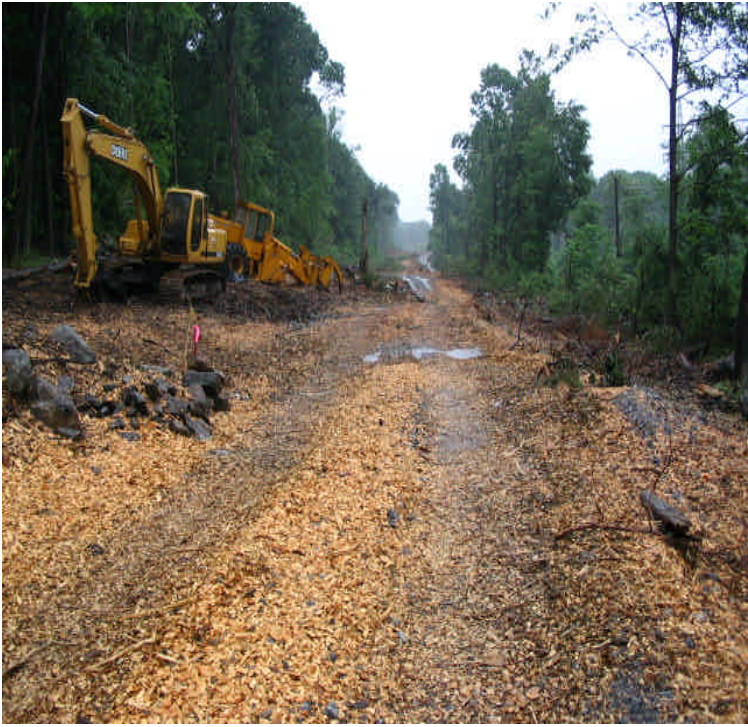
Photo on the left shows an overview of the cleared new section of ROW where most vegetation is removed. Trees still will be removed along the railroad tracks. Photo on the right shows a matted area with some evidence of shrubs having been retained. 6/7/06

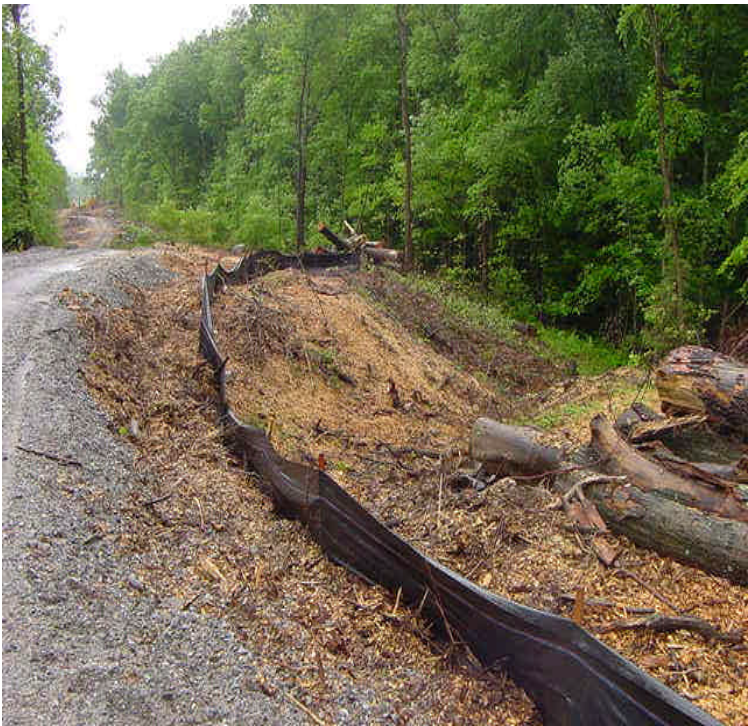
Photo on the left shows where the silt fence was installed along the natural swale area as recommended. Photo on the right shows the matted crossing at the stream with silt fence installed at each corner. 6/7/06

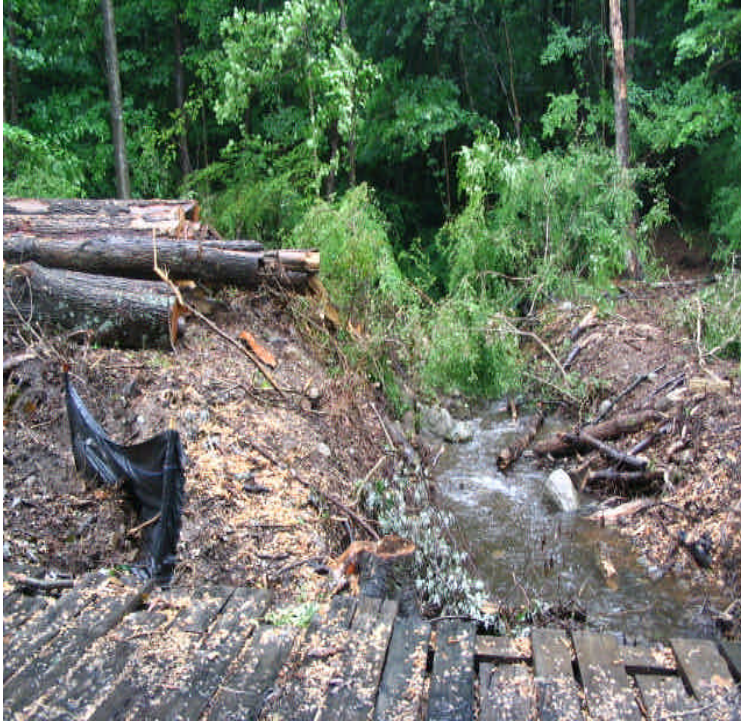
Photo on the left shows the stream crossing under the mats. Water was fairly free of turbidity but silt fence should be extended along the banks to prevent run-off and branches in the stream should be picked up carefully by hand. Photo on the right shows the matted crossing at the pooled area. Water here is also free of turbidity issues. 6/7/06

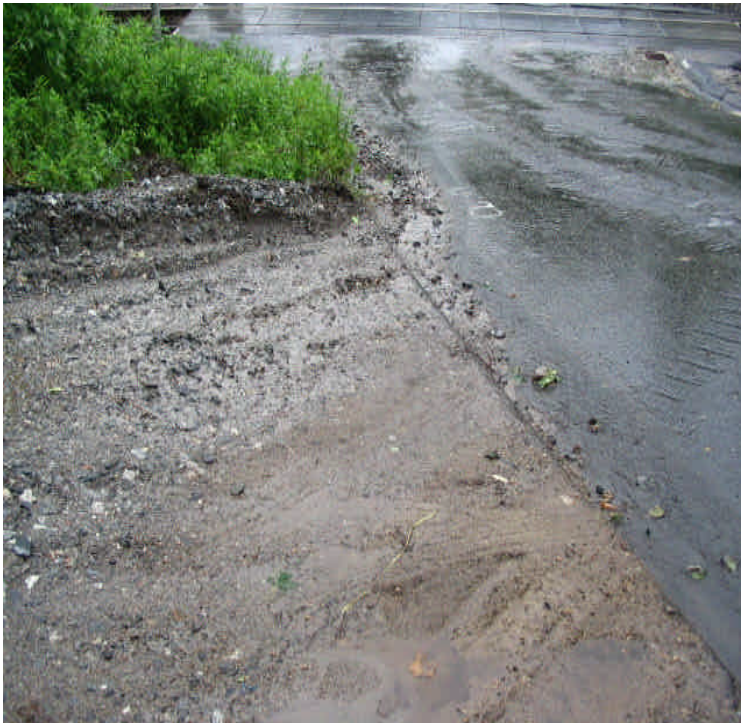
Photo on the left shows the intersection of the ROW with Kent Rd. A stone pad should be installed here to help filter/reduce run-off. Photo on the right shows a view of some ruts and disturbance near a matted crossing to the south of Kent Rd. Repair as necessary. 6/7/06

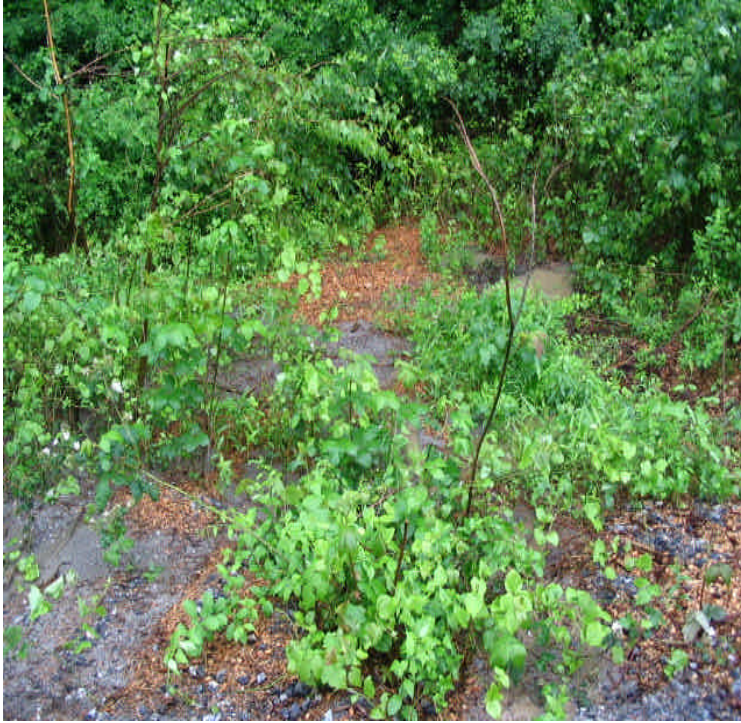
(Kent Rd: south): Photo on the left shows a spot where gravel washed beyond the silt fence at a matted crossing. Remove any sediment/stone on the other side of the fence Photo on the right shows where turbid water was overtopping silt fence along the mats during the heavy rain. This was noted in several locations along this section of ROW. 6/7/06

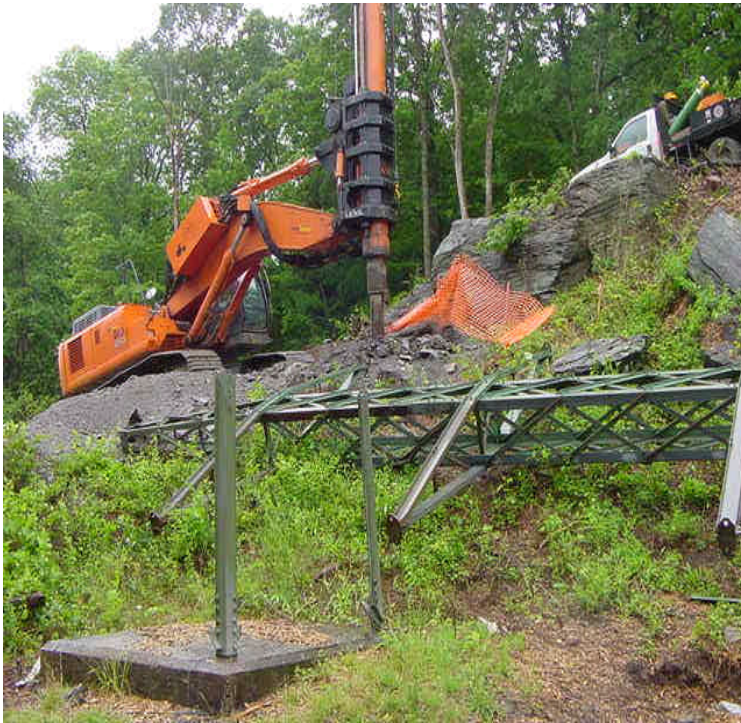
Photo on the left shows drilling at a structure location along Kent Rd to the south. Photo on the right shows a view of the Perry Ave section where construction of new structures continues. 6/7/06
